EFFECTS OF THE ATOMIC BOMB ON NAGASAKI,
JAPAN

Physical Damage Division

JUNE 1947

13 October-20 November 1945

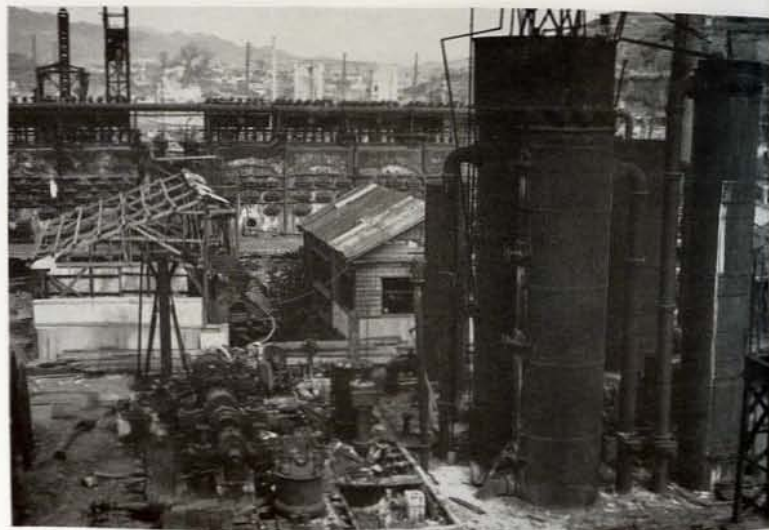
PHOTO 54.—6,600 feet from GZ. View of machinery and scrubbers, Yachiyo-Machi Gas Works.

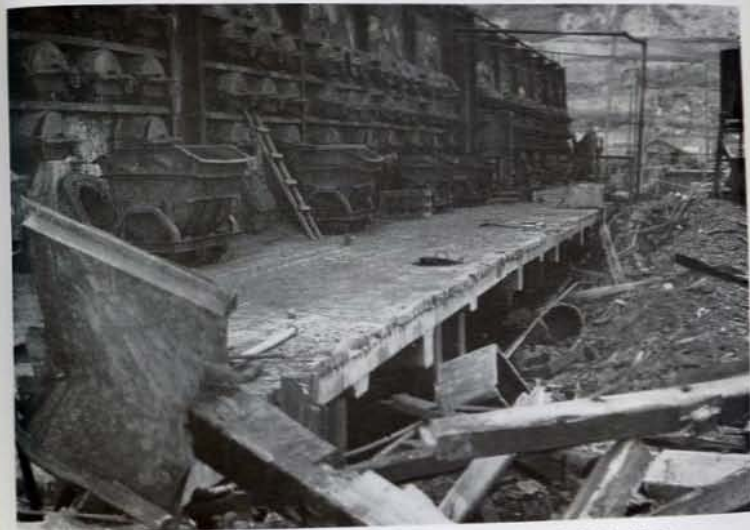
PHOTO 56.—6,600 feet from GZ. View of gas retorts, Yachiyo-Machi Gas Works.

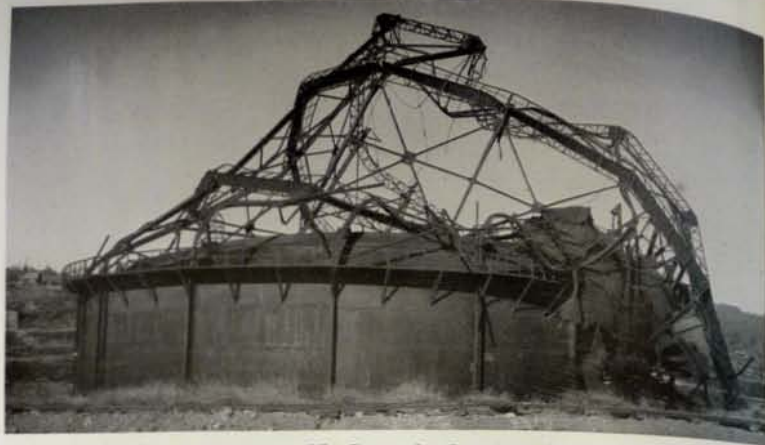
i. The holder was damaged almost beyond repair as shown on Photos 57-61. A summary of the superficial damage to the other equipment is shown in Table 8 (Photo 62).

PHOTO 57.—3,000 feet from GZ. Damaged tank structure, Chashi Gas Works.

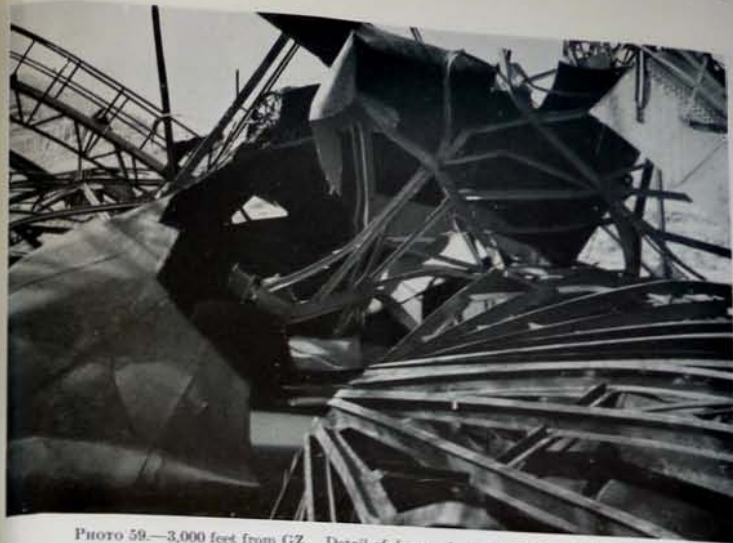
PHOTO 59.—3,000 feet from GZ. Detail of damaged gas holder, Ohashi Gas Works.

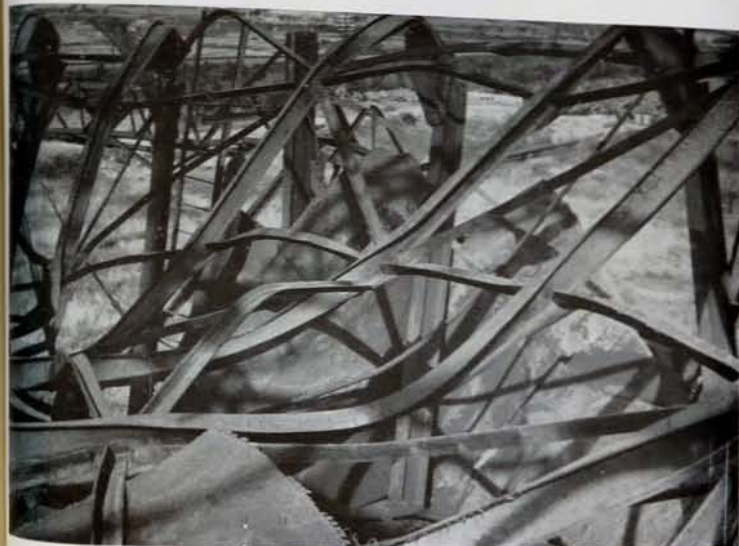
PHOTO 60.—3,000 feet from GZ. Deformed tank structure, Ohashi Gas Works.

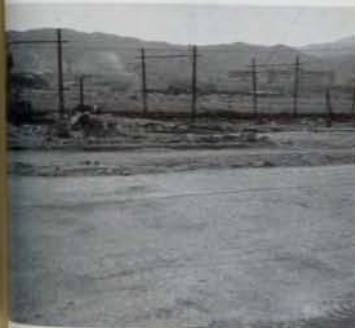
d. The trolley wires were supported by steel standards as shown in photo 64 which was taken at a point 600 feet from GZ. The wires were displaced over most of the system and many standards were damaged. Photos 65-66 show view of damaged trolley wires and supports at approximately 1650 feet from GZ.

PHOTO 64.—600 feet from GZ. General view of street car track. In foreground is overturned wood standard.

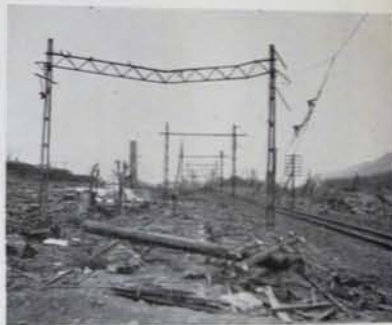
PHOTO 65.—450 feet from GZ. Damaged steel standards and wires for street railway. Note portion of car roof on standard.

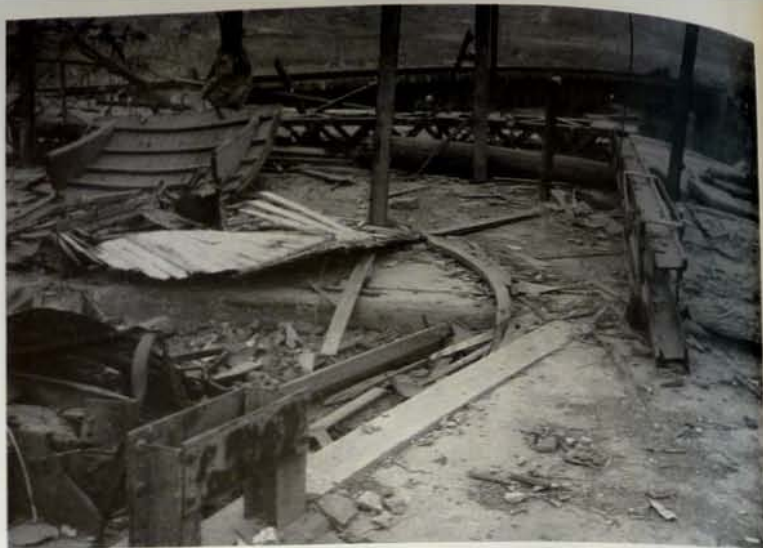
Photo 66.—1,650 feet from GZ. Steel standard sheared by blast and thrown 7 feet in a northerly direction. car top.

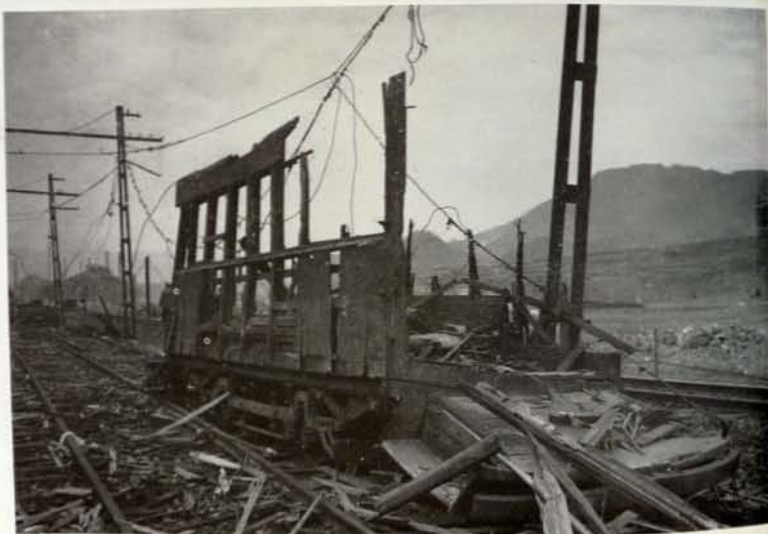
e. The terminal of the system was located 1,500 feet north of GZ where eight cars were located at the time of the explosion. All were totally damaged, three by fire and five by blast. Photo 67 shows a car approximately 300 feet from GZ.

Photo 67.—300 feet from GZ. Street car damaged by blast.

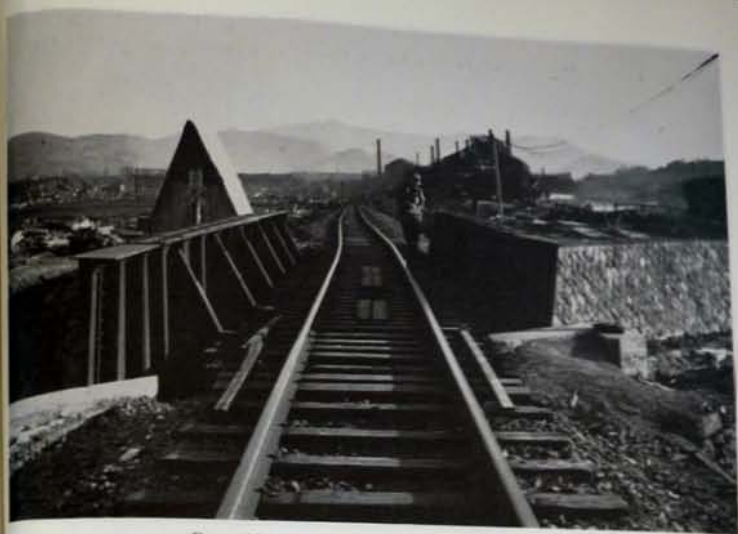
c. Three railroad bridges were displaced by the initial blast wave, thereby damaging the tracks. Bridges 8, 26, and 27 were of built-up, steel girder design, and had open cross ties but no solid decks. There was no evidence of fire on bridge 26 (Photo 68) and 27, but on Bridge 8 the cross ties were charred and required replacement. For further study of damage to bridges reference is made to Part 6 of this report.

Photo 68.—840 feet from GZ. Damaged Bridge 26.

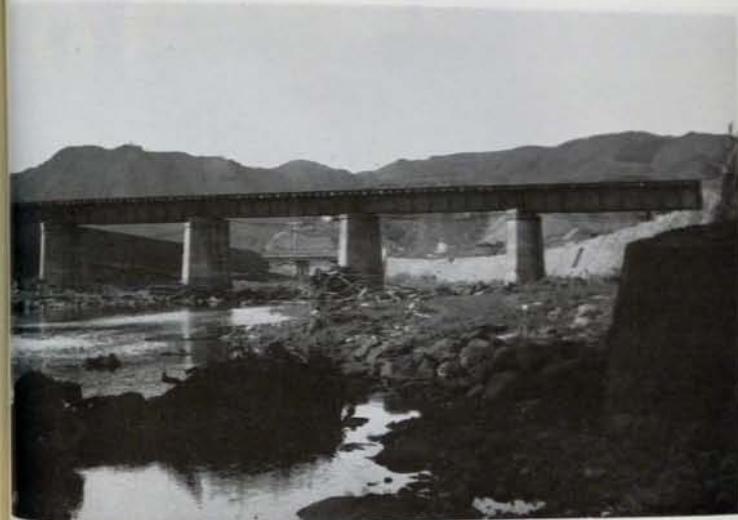
Photo 69.—1,750 feet from GZ. Damaged Bridge 8.
